Assistance with Safety Evaluation for Two Dams

- Geotechnical investigation, analysis and recommendations for the construction of the downstream dam to comply with the NJDEP requirements for Class III dams
- Design drawings and specifications for the refurbishment of a breached and partially constructed dam

An existing farm pond on a 126-acre farm in central New Jersey had been breached in order to lower the water surface elevation so that the pond could be dredged. In addition, a large dam had been partially constructed downstream of the existing farm pond to form a second larger pond. Both projects were performed without design or the assistance of a professional engineer. The NJDEP performed a site visit and issued a written order to stop work. The NJDEP requested that a geotechnical evaluation be performed to assess the stability and safety of the dam, and that the owner comply with the Dam Safety regulations and permits.

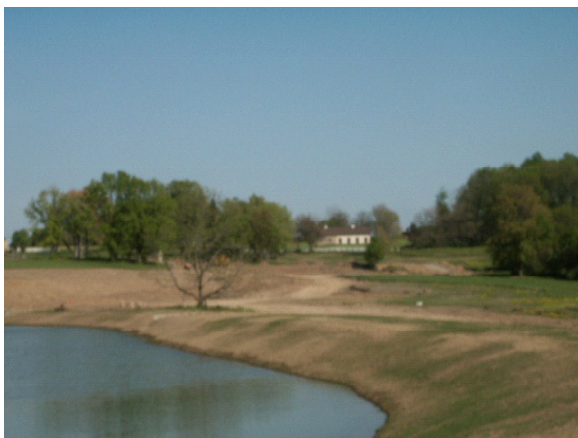
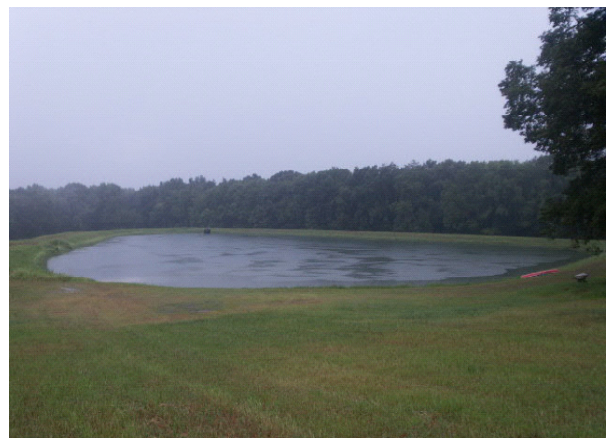
To insure the continued stability of the two dams, global slope stability and veneer stability of the GCL and the cover soil were performed. The slope stability analysis was performed using the computer program X-STABL. The program performs a two-dimensional limit equilibrium analysis to compute the Factor of Safety for a layered slope according to the general limit equilibrium method, Janbu's Generalized Procedure of Slices, Simplified Bishop, and Simplified Janbu. In addition, the veneer stability of each component of the linear system was evaluated, including the stability of the GCL itself, the GCL/subgrade soil interface and the GCL/cover soil interface. The stability of the GCL liner itself was calculated using the hydrated strength of the bentonite clay sandwiched between the two geotextiles. The stability of the GCL/subgrade interface and the GCL/cover soil interface were calculated utilizing the interfacial friction angle between the different surfaces.

SAI examined several aspects of the earth dam to ensure the performance and stability of the structure. A seepage analysis was performed to determine the amount of water flowing through the dam. A flow net diagram was constructed for the existing dam. It was concluded that there was an excessive amount of seepage, and that remedial measures should be taken to reduce it. Accordingly, SAI recommended that the inside slopes of the dam be lined with a material of low permeability; specifically, a geosynthetic clay liner (GCL). In addition, the Factor of Safety against rapid draw down was calculated utilizing the Stability Charts developed by Spenser.
